SUBJECT: Site Inspection, Rock-It Stone, Strawberry River Quarry, S/013/008, Duchesne County, Utah

Date of Inspection: August 21, 2003

S/013/008, Strawberry River Quarry, Rock-It Stone Works

Inspection Dated: August 21, 2003; Report Dated: September 5, 2003

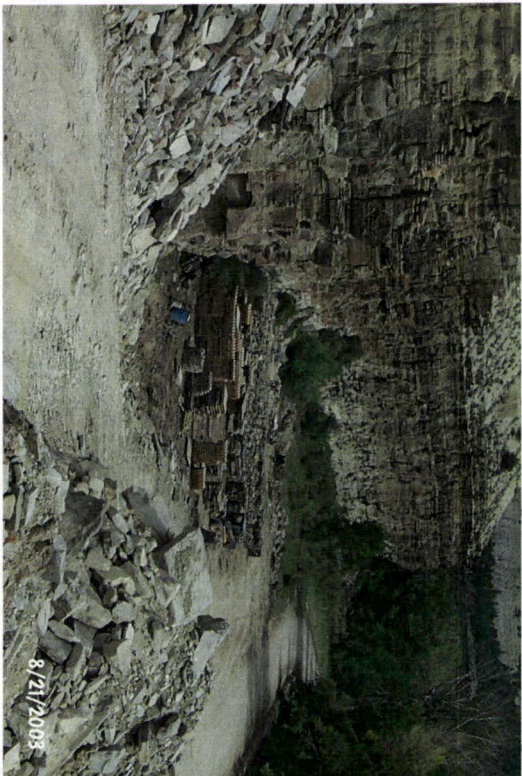
Previously, the operator had been taking stone primarily from a pile in front of the cliff that had been left by a former operator. Although it appears this is still occurring, it also appears the operator has been using the trackhoe to pull rock from the cliff. This area is shown in Photos 1 through 4. There is a pile of what appears to be largely waste material, and a road extends from the county road up this material to the base of a highwall/cliff (Photo 1). The operator is probably still taking stone from this pile.

Equipment on site includes a trackhoe and a rock splitter or guillotine. Photo 1 shows some of the pallets and stockpiled stone adjacent to the road.

Photo 1. View looking approximately east toward the pallets and stockpiled stone at the base of the cliff.

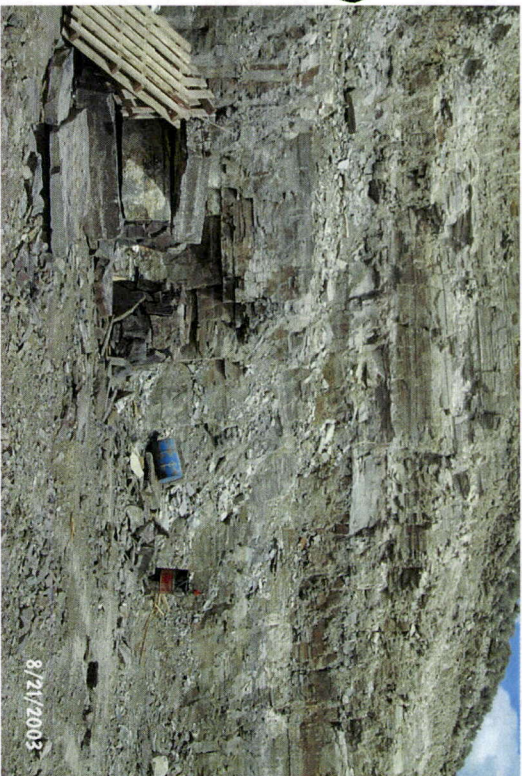
Photo 2. Cliff from which the operator has been quarrying stone.

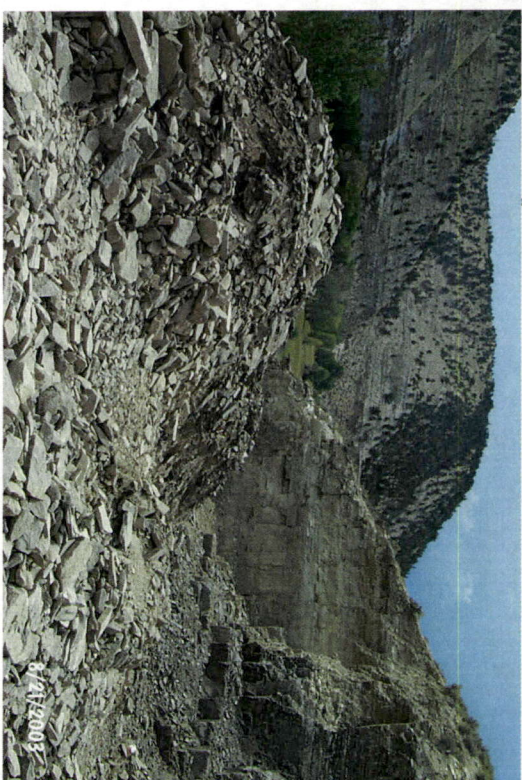
Photo 3. View looking approximately west.

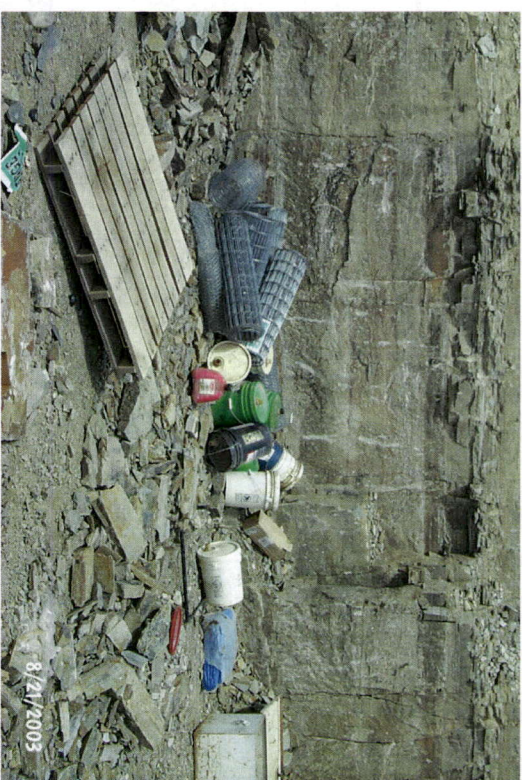
Photo 4 shows some fencing material and some used oil buckets. Some of the buckets appear to be garbage and should be cleaned up, but, to the operator's credit, the trash is kept relatively neatly in one location rather than being scattered all over the site.

Photo 4. Trash and other material next to the highwall/cliff. The trash needs to be cleaned up.

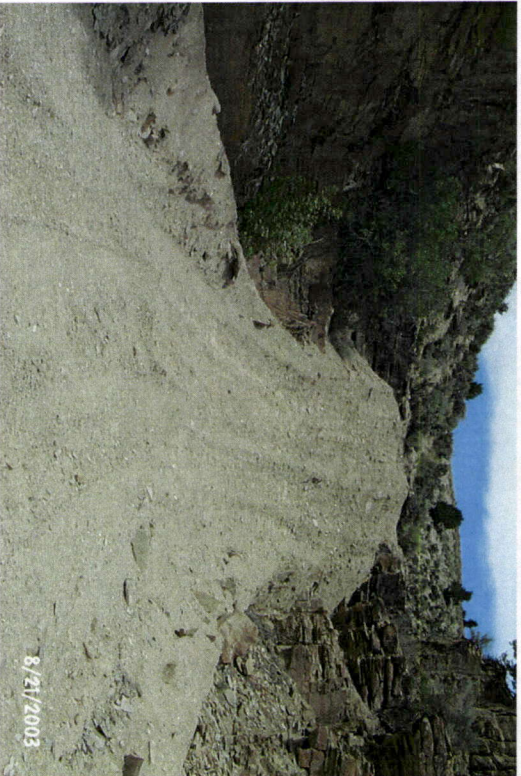
Since the last inspection, fill has been placed in a small drainage to the west of the quarry to create a road to the area above the cliff (Photos 5 and 6). This is a very steep road, and we questioned whether anything other than a dozer could climb the road.

The small mining notice of intention indicates mining activities would be confined to the southeast quarter of Section 16, Township 4 South, Range 7 West, USM. The drainage in which the operator has placed fill is clearly not within this area, so the operator needs to amend the notice of intention and show he has right of entry to this area.

I am concerned about the fill placed in the drainage. The bottom of the drainage is just across the road from the Strawberry River, and the fill appears to have enough fine grains that some could erode into the river. There needs to be something of a channel coming down this drainage. The operator could direct runoff water toward the side of the drainage and build a riprapped channel. Another option might be to armor the top of the access road in a way that it serves as the channel. It appears the operator has plenty of rock available with which this could be done.

**Photo 5. Fill placed in a small drainage west of the quarry for access to the area above the quarry.**

In addition to having an armored channel, there needs to be other sediment control for runoff and sediment coming off the road. I assume there is a culvert under the county road near this point and suggest that the operator could install a silt fence to keep some of the sediment out of the river. Straw bales would also work, but they would probably be destroyed by the many cattle in the area.

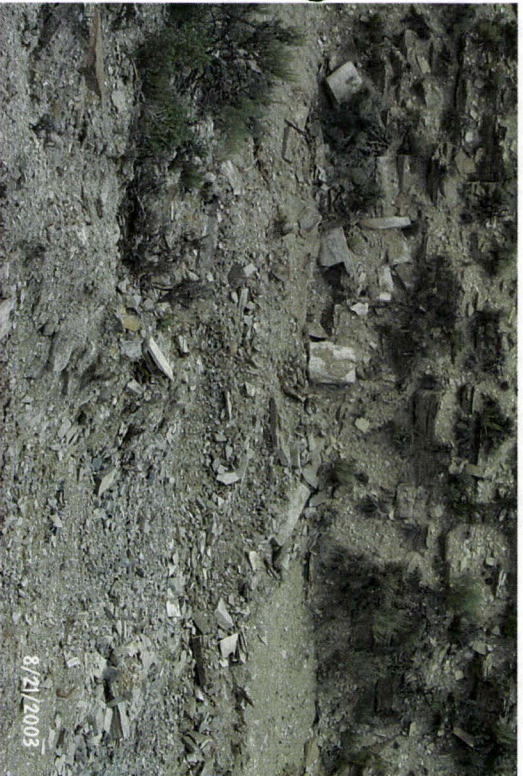
**Photo 6. View down into the drainage shown in Photo 5.**

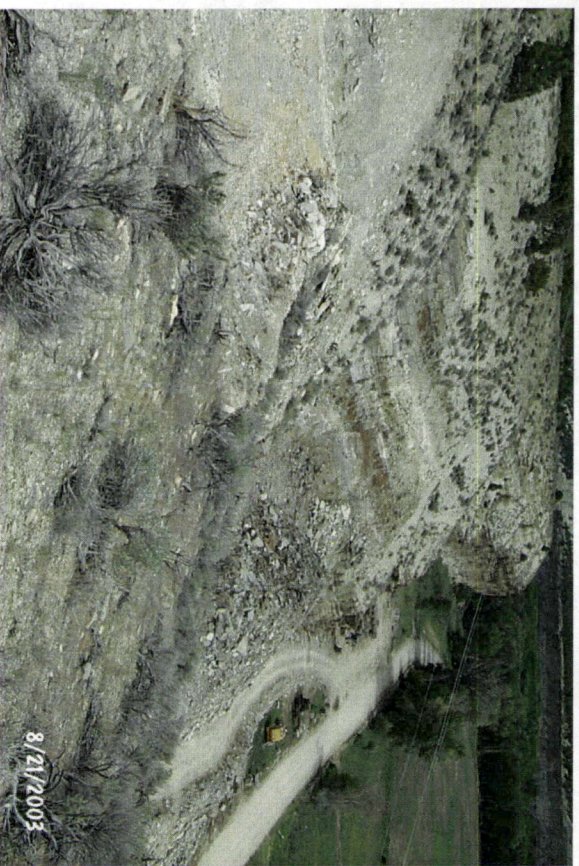
Photo 7 is a view from the top of the highwall/cliff down toward the operation next to the county road. Photo 8 is a panorama of the area above the highwall that has been cleared, apparently of overburden.

**Photo 7. View from above the highwall/cliff toward the operations adjacent to the county road.**

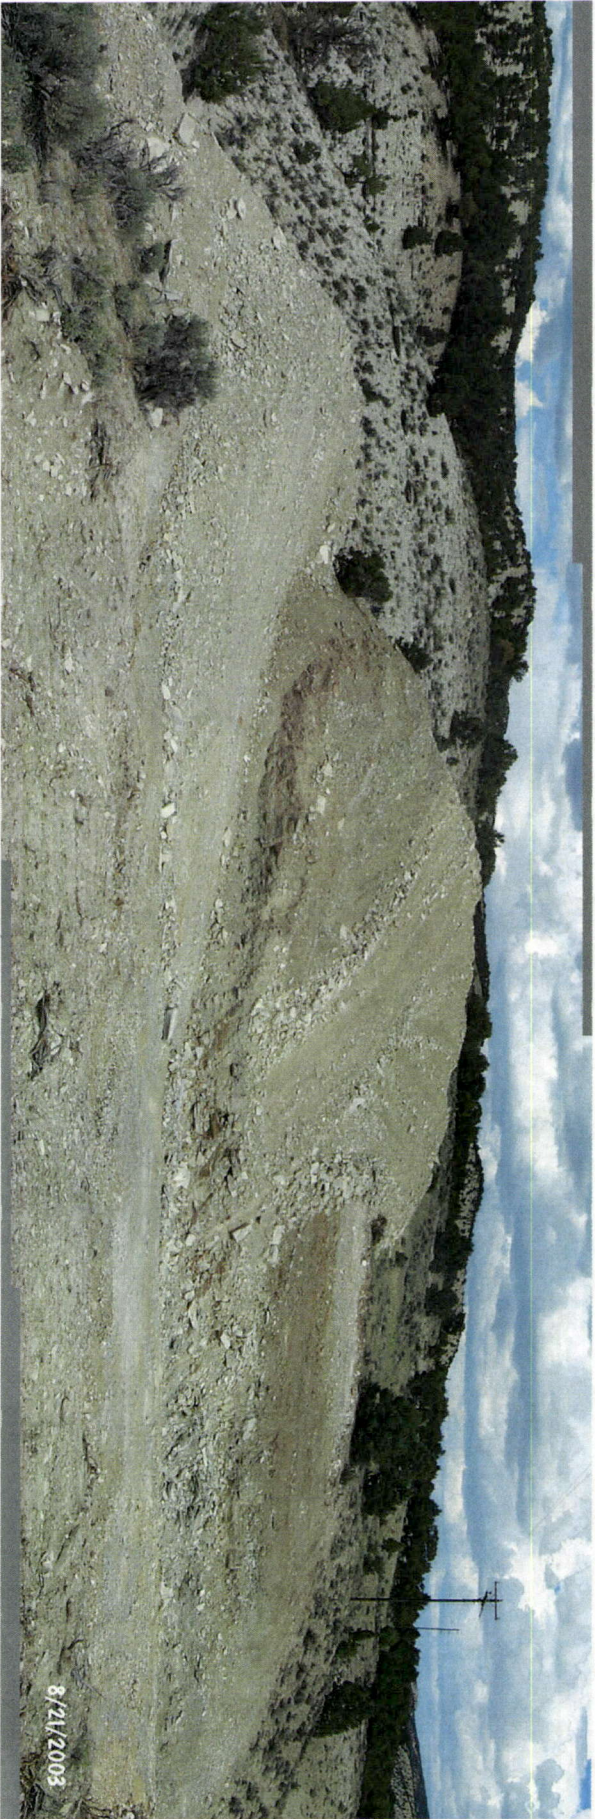
The larger disturbance above the cliff may also be outside the southeast quarter and the permitted area, but it is impossible to tell with certainty from the information available to the Division.

**Photo 8. Panorama of the cleared area above the quarry. This panorama consists of three photos stitched together.**

When the Division originally accepted the notice of intention for this operation, it approved a variance from topsoil salvage requirements. It now appears it may be easier than originally envisioned to salvage soil from the area above the highwall/cliff. The Division cannot now require the operator to salvage this soil, but it is in the operator's best interest to salvage anything that might be available.
